National Conference for Undergraduate Research 2019 Kennesaw State University

Low Cost Remote Algae Detection Utilizing Embedded Hardware, Custom Sensors, and Additive Manufacturing

Charles Wade Department of Electrical Engineering and Computer Science The University of Toledo Toledo, Ohio

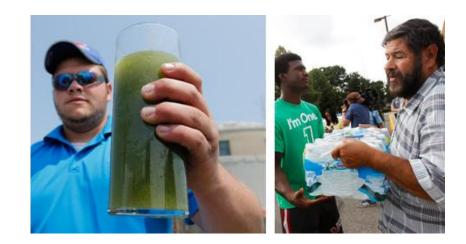
Estimated economic impact of the 2014 algae bloom in Toledo, Ohio, according to National Ocean and Atmospheric Administration(NOAA)

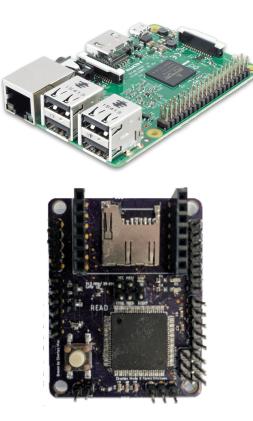
Data Logging

- Raw sensor data is **relayed over radio to a gateway** module.
- This data is then stored in a **SQLite database**.
- A web server provides API access to an Android application that displays detectors on a map.

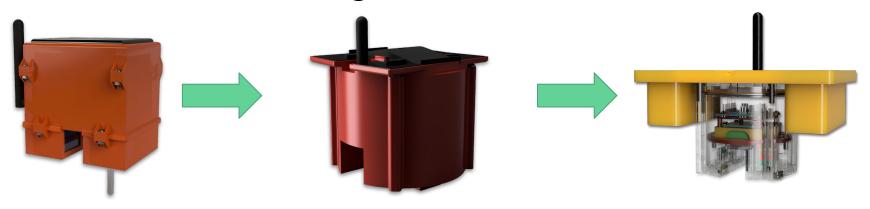
Design Evolution

- Different 3D printed housings were tested in water.
- **FDM** and **SLA** printing were both tested.
- The current design utilizes both FDM and SLA techniques.

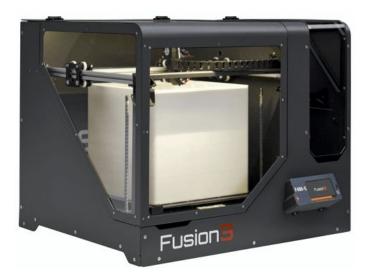
3D Printing Test Setup

FDM: Fused Deposition Modeling

Materials: PLA, ABS, PETG

- FDM printing worked best when printed with
 >90% infill using PETG or ABS filaments,
 however was still susceptible to leaks after
 spending more than 3 days in water.
- Leaks were caused by water entering the imperfections left behind from layer adhesion.
